AFIT/GAE/ENY/89D-34

IMPACT DAMAGE TOLERANCE OF  
COMPOSITE CYLINDRICAL PANELS

THESIS

Eugene A. Senn  
Captain, USAF

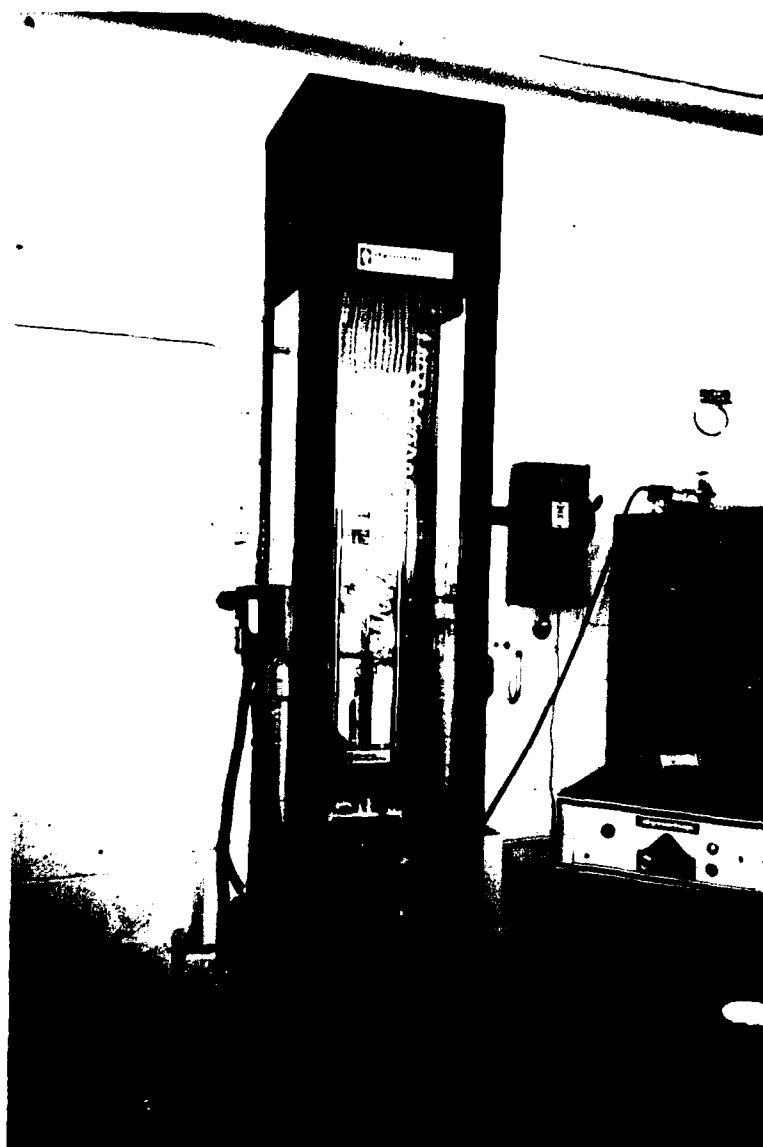
Figure 2.2 - Dynatup Impact Test Machine

The panels were subjected to a single, transverse (-z direction) impact normal to the surface of the panels. A GRC 8250 Dynatup Impact Test Machine (hereafter called Dynatup) made by General Research Corporation, was the test fixture used (see Figure 2.2) [12]. The impactor used was a 1/2" diameter tup weighing approximately 5.5 pounds and instrumented with an accelerometer to measure the contact force between the tup and the panel. The data obtained from the accelerometer is acquired and analyzed by a GRC 730-I Instrumented Impact Test Data System.

The panel-support block assembly is placed on an adjustable support plate underneath the impactor. As was mentioned earlier, the mass of the impactor used was approximately 5.5 lbs. Therefore, the impact velocity and subsequently the energy is varied by changing the drop height. For the Dynatup, the drop height was set using a tape measure. The height can be adjusted by using an Up-Down switch on the control panel shown in Figure 2.2.
